MORRIS CANAL

ARCHAEOLOGY AT LOCK 2 EAST

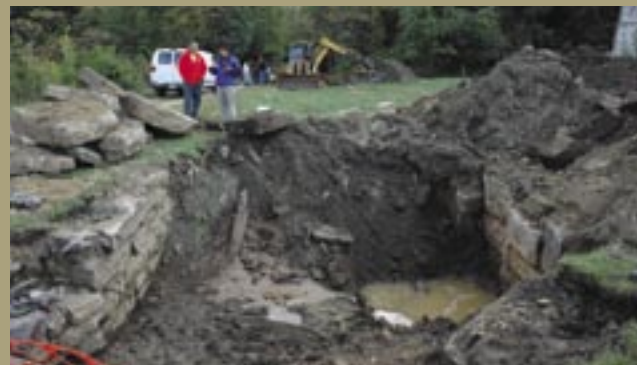
In the fall of 2006, archaeological investigations showed that the stone walls of Lock 2 East are still intact below ground level.

In the fall of 2006, as part of a restoration plan, archeologists dug to see if the lock could be rebuilt. Their excavations showed that, although many wooden parts had rotted away, the lock walls were intact and many iron artifacts had survived. Parts of the wicket valves were discovered at the upper end of the lock and carefully conserved to demonstrate how the lock works.

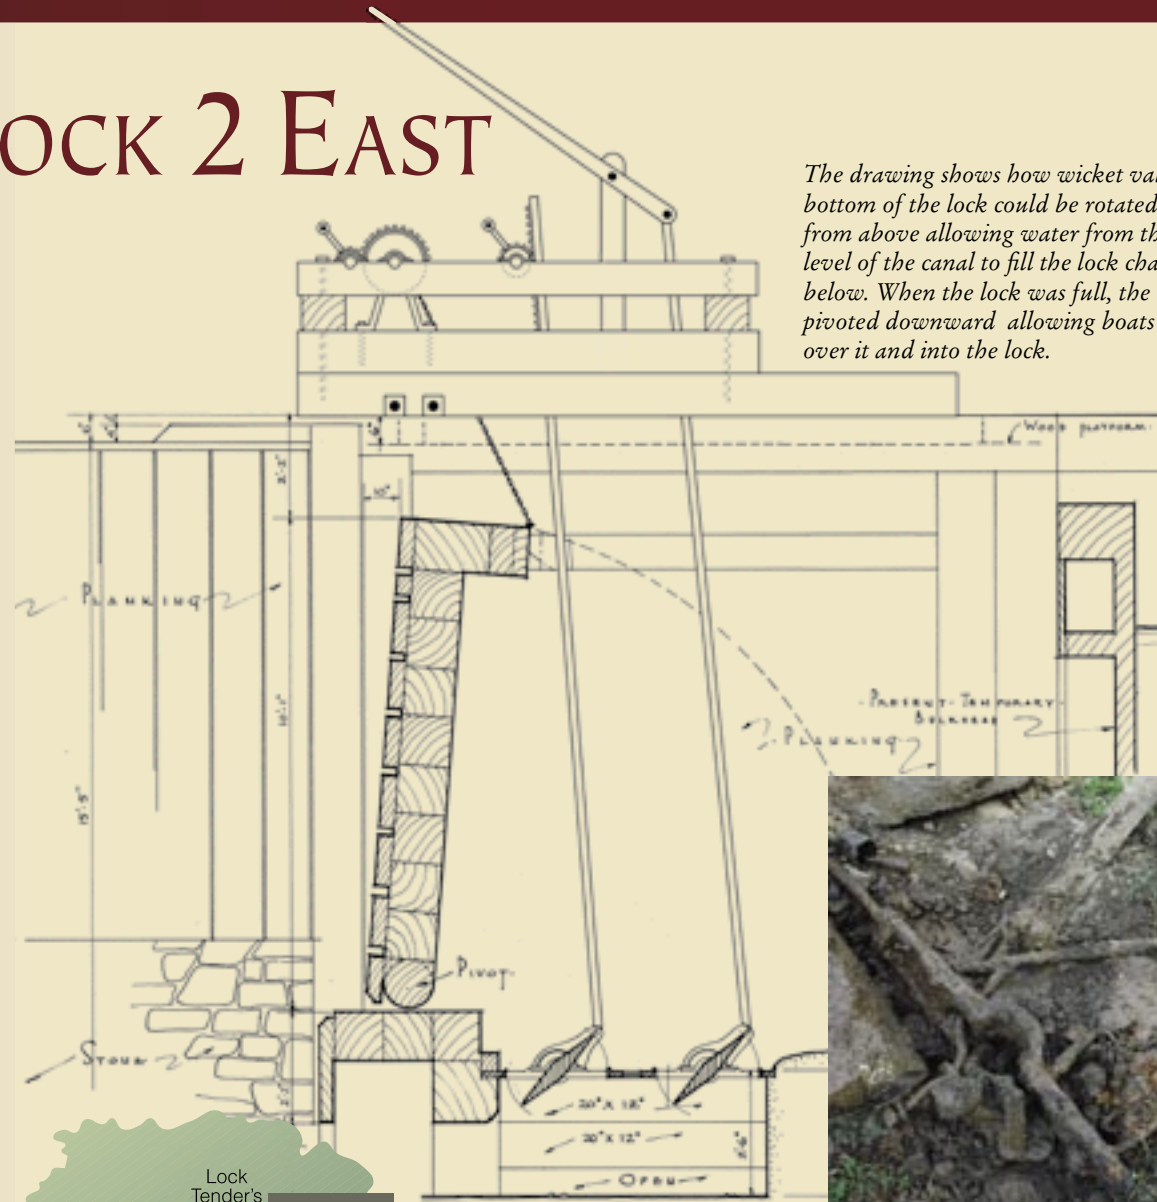
The drawing shows how wicket valves in the bottom of the lock could be rotated by a lever from above allowing water from the upper level of the canal to fill the lock chamber below. When the lock was full, the drop gate pivoted downward allowing boats to float over it and into the lock.

The upper end of the lock was controlled by a drop gate that pivoted down into a pocket in the bottom of the lock. Below the drop gate, paddle valves called wickets could be opened by means of a lever and crank from above. The lock tender would first raise the drop gate and then open the wickets to fill the lock with water. A boat in the lock would be raised to the next higher level of the canal.

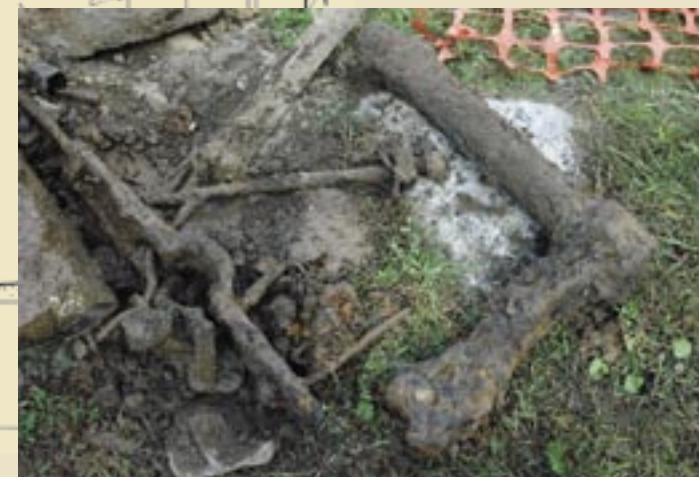
The wicket gate pillow block, bolts and shaft assembly as they appeared when first removed from the ground.

When archeologists excavated the upper end of Lock 2 East, they discovered that the lock walls were intact and, although the wooden parts of the wicket valves had rotted away, some of the metal parts had been preserved. After careful restoration, these parts help demonstrate how the lock worked.

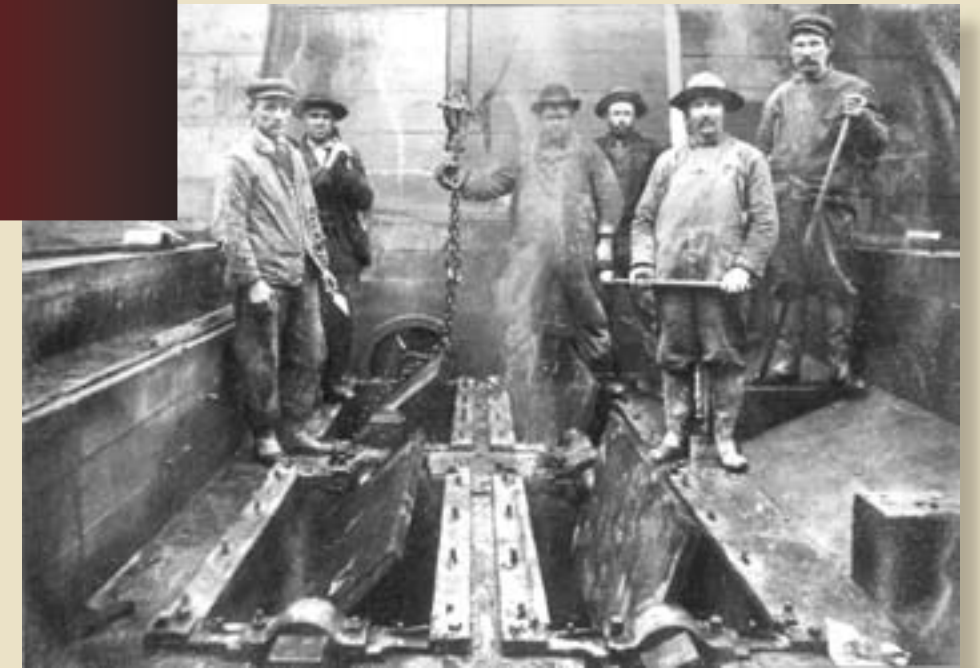
A work crew on the Lehigh Canal stand in the bottom of a dewatered lock with the wicket valves open at their feet.

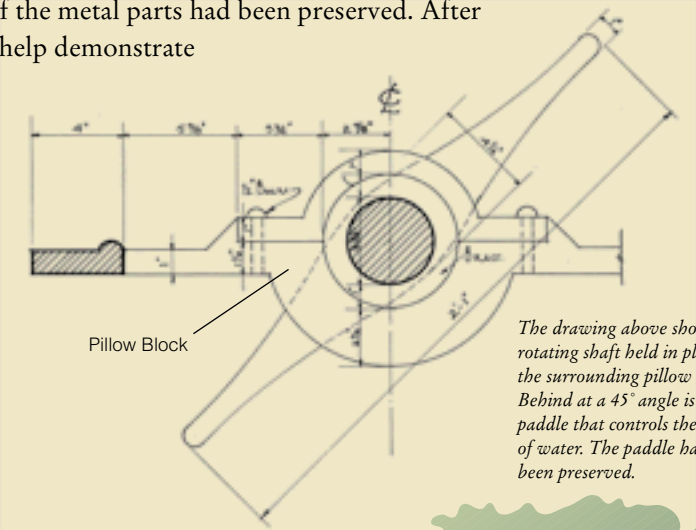
The drawing above shows the rotating shaft held in place by the surrounding pillow block. Behind at a 45° angle is the paddle that controls the flow of water. The paddle has not been preserved.

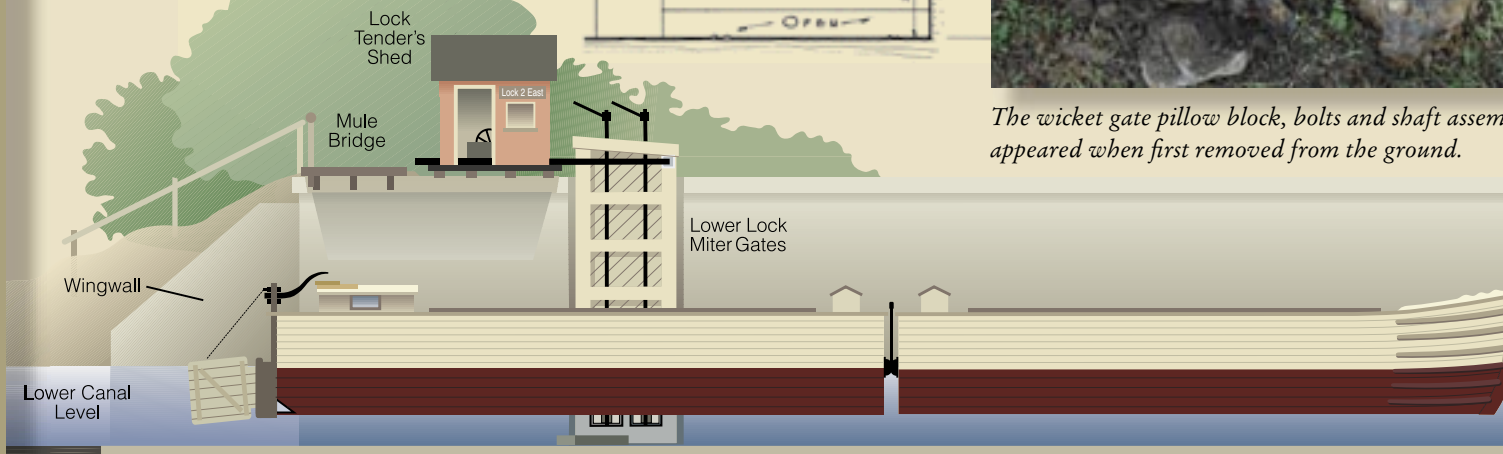
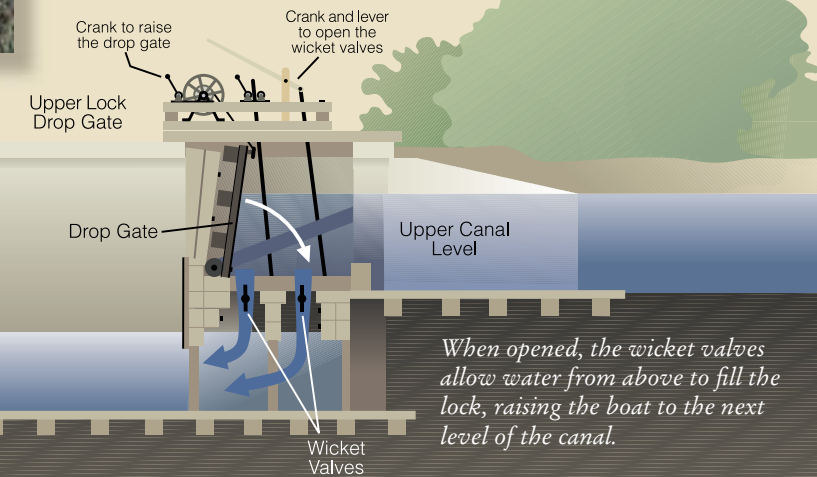
When opened, the wicket valves allow water from above to fill the lock, raising the boat to the next level of the canal.
